Chapter 526 **SpotLight**

Steve Jahr Arion-Lightning

Pilot/Owner: Steve Jahr Aircraft: Arion Lightning

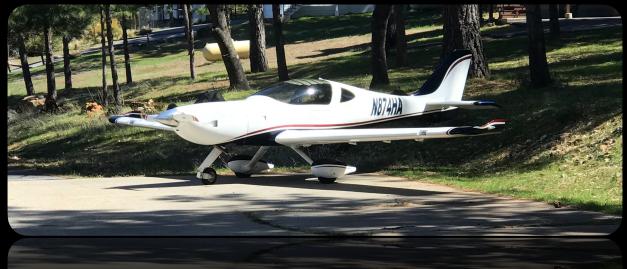
Rotec Alternator Kit

The first time he tried starting the plane it would crank over, but it just wouldn't start. Steve had to charge/jump the plane to get it going and flew his first leg to Dumas, Texas. The next morning he headed to the airport ready to tackle the next leg but the plane again wouldn't start. They jumped the plane for him and because of weather delays, he

The Jabiru engine is very lightweight but it comes with some limitations. Remember those problems having to charge/jump it to get started? After more research and testing, because the engine uses a Dynamo Alternator, it doesn't start charging the battery until the engine is running at 1,800rpm or greater. So what that means is that during startup and taxi, the plane is running off the battery. The fix is to install a proper 40A alternator. Steve purchased a Rotec belt drive alternator kit - problem solved ... but there's more.

The engine uses simple lawn mower type ignition coils and they don't produce a spark until the engine is cranking at 300rpm. The fix for this is a Rotec Electronic Ignition system that's enabled, or turned on, via the oil pressure switch. Replacing the Dynamo Alternator with a standard

Alternator meant he lost his Tach signal, so upgrading to an electronic ignition system solved multiple issues at the same time.
